**American Avalanche Association
Forest Service National Avalanche Center
Avalanche Incident Report: Long Form**

Occurrence Date: 18 APR 2009 **Time:** 1245

Alaska Avalanche Information Center

Peak, Mtn Pass, or Drainage: Nicks Gulley, Thompson Pass

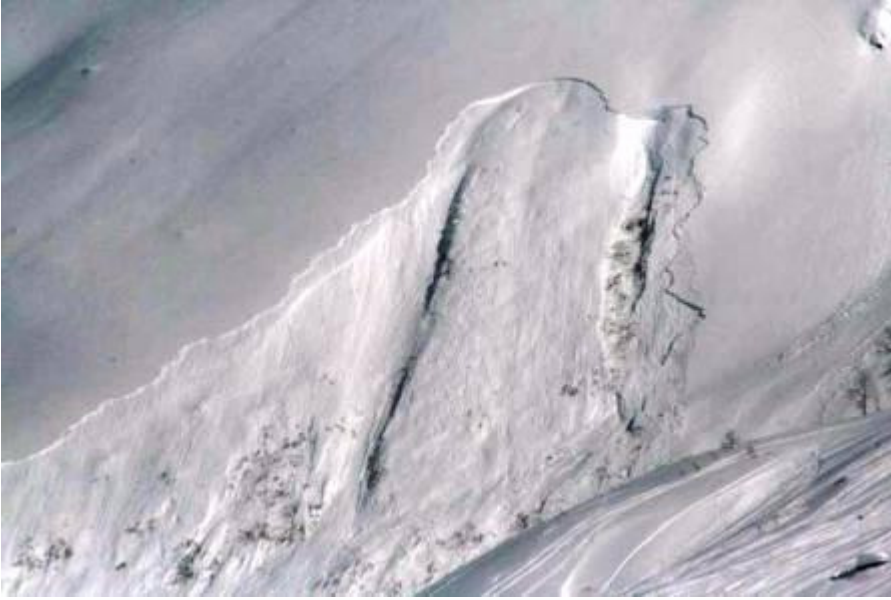
The slope that failed was crossloaded during February and March northerly outflow wind events. The crown averaged 1m thick but thickened to more than 2.5m in center of the loaded gully terrain feature which failed. See attached photographs. On the day prior to the accident, a similar crossloaded feature on part of the adjacent slope (the same one with the 081201 size D3) was remotely triggered by a snowmachine competition producing a D2.5.

Photo taken on 04/18/09 immediately following avalanche by spotters on ridgeline who were searching debris with telephoto camera lens.

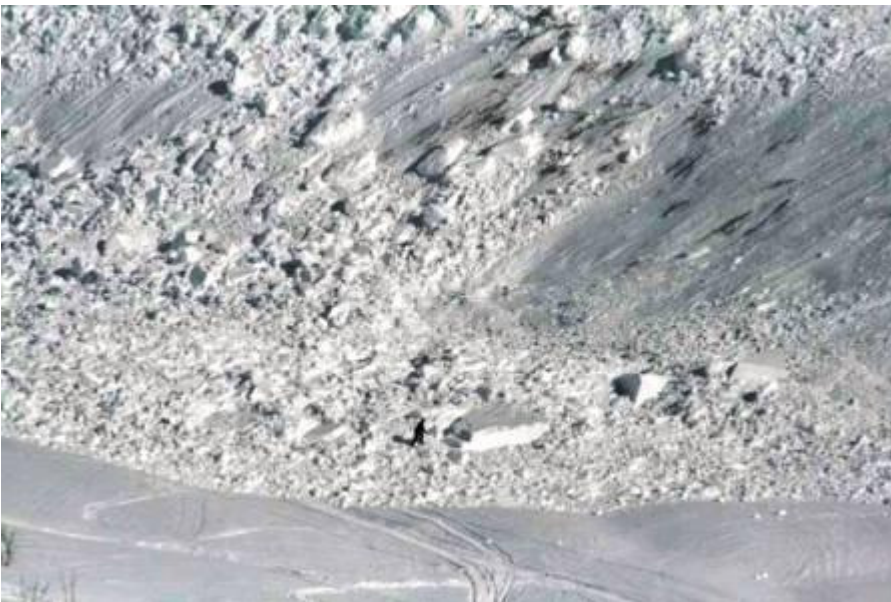
Photo taken on 04/18/09 immediately following avalanche by spotters on ridgeline who were searching debris with telephoto camera lens. Person visible in photo was the victim's nephew who was looking for the victim prior to rescuers arriving on scene. Note hard slab debris and large blocks.
